Town of Arlington

DRAFT REPORT

ADA Self-Evaluation (as basis for Transition Plan)

Prepared by
Institute for Human Centered Design
September 15, 2014

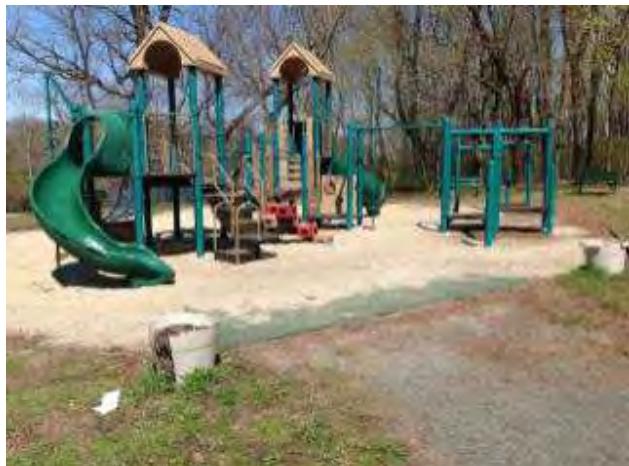
Photo 7

One large sandy area contains three separate zones of play structures. Although an accessible route is provided to the large play structure, the transition between stone path and rubber surface is in poor condition. (Photo 7)

Repair the transition between stone path and rubber surface at the large play structure and install an accessible walkway between points of entry and the swingset and the small play structure. The accessible route to these play areas can adjoin the new accessible walkway through the facility.

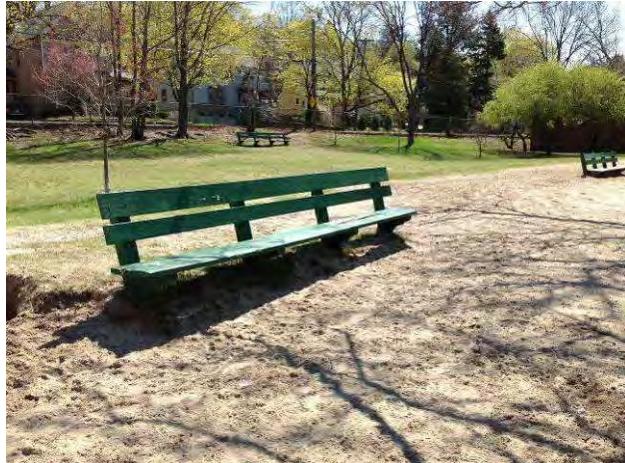
Photo 11

Several benches are provided through this facility. They can be found along the sand path and trees, within the grassy knoll near the fence on Lowell Street, within the playground, and near the water's edge. Neither is accessible because they do not adjoin an accessible route. (Photo 11)

Although not a requirement under the ADA, consider providing at least 50% with armrests, as benches are replaced (total of 10 benches).

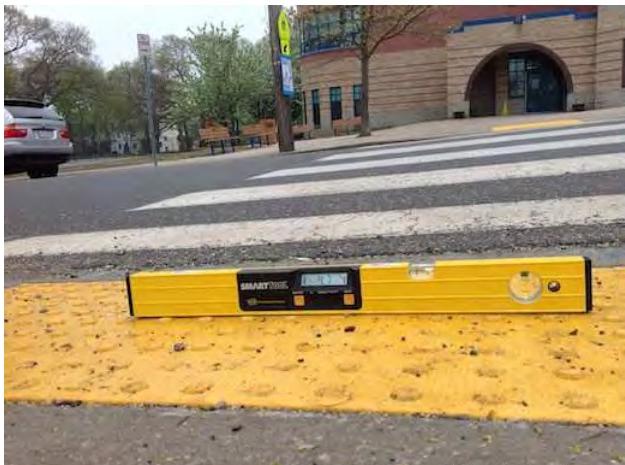
Photo 2

(Photo 2)

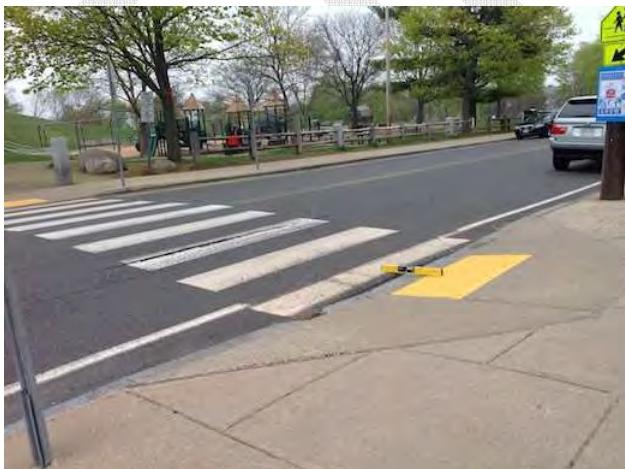
Photo 3

The curb ramp on school side of crosswalk also has a noncompliant run slope and an excessive vertical depression at the gutter to ramp transition, leading to water and ice accumulation issues. (Photo 3)

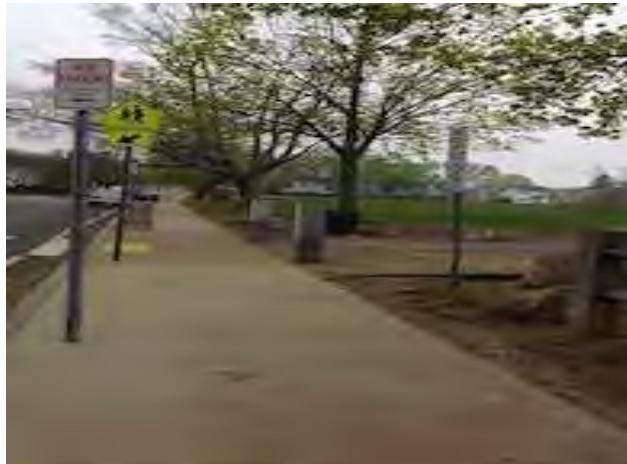
Photo 4

Sidewalk along Eastern Ave. has noncomplying cross slopes. (Photo 4)

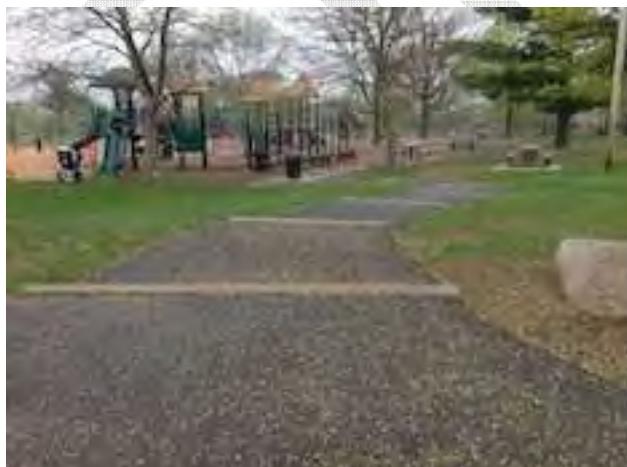
Photo 6

The only interior connection between these 2 entry walkways is an inaccessible wide tiered stairs route with *no* handrails.

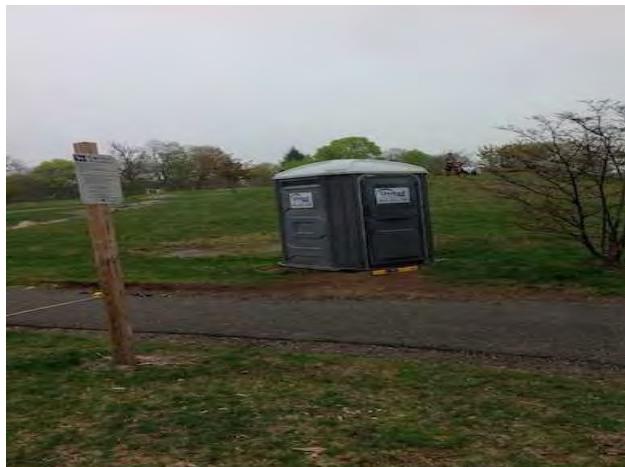
Photo 8

The walkway extending from the school crosswalk entrance provides an at-grade entrance and access to the Long Hill Slide/staircase top and the Boston Skyline Viewing Oval. This route has some cross and run slope issues that can be mitigated with small wall or handrail supports. This walkway does not connect to the border of field sports activities, the 2 sides of the court, the benches on Baseball Hill, or the portable toilet entrance. (Photo 8)

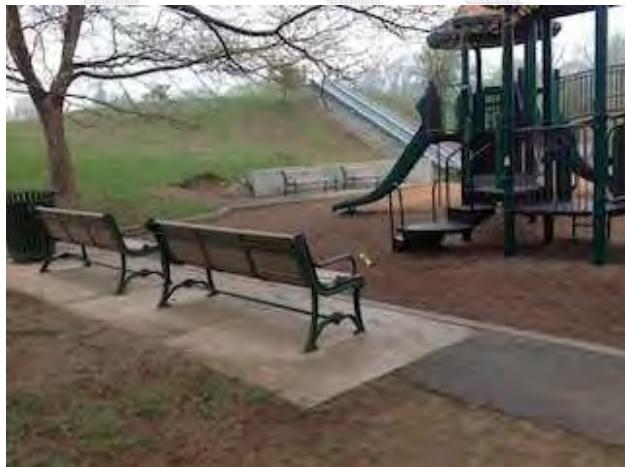
Photo 9

Although the walkway from the entrance west of the school crosswalk leads to the play areas and benches, it does not provide an accessible connection because of level changes and lack of clear width. (Photo 9)

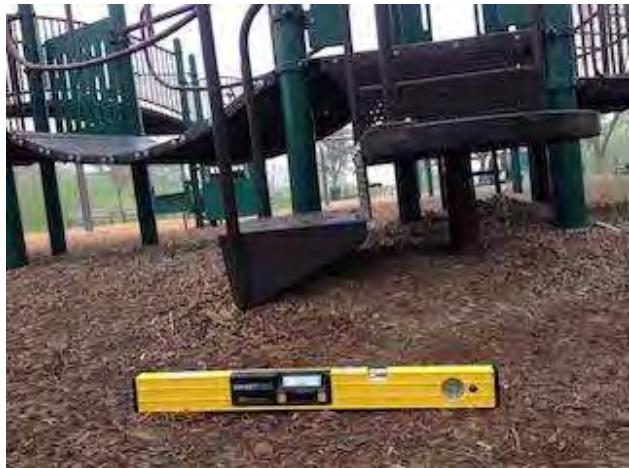
Photo 10

The bordered playground is surfaced with loose-fill ground surface materials.

Loose-fill surface materials require frequent maintenance to ensure accessibility in all seasons. These play areas do not currently offer accessible circulation routes because the ground surface materials have excessive cross slopes, depressions, and protrusions near and within ground play elements and transfer stations. (Photo 10)

- a. If only loose fill ground surface materials are used, implement a high-frequency maintenance program to ensure accessibility of ground surface materials through all seasons.
- b. If ground surface materials will be replaced: consider adding unitary surface materials within the playground areas to provide accessible routes and clear ground spaces to all entry/exit points of ground play elements, including swingsets, play structure transfer station, and ground play elements.

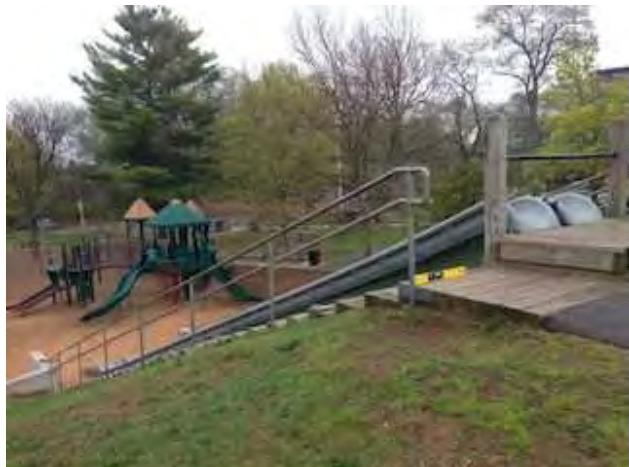
Photo 11

The recessed playground area is the exit point for the Long Hill slides and accommodates 2 play areas that are age-appropriate. There is no accessible connecting route between the bottom and the top of the slide. (Photo 11)

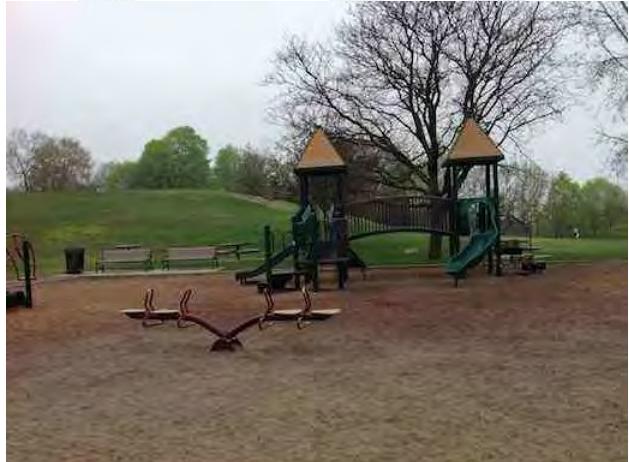
Photo 12

The play structure for younger children has an exceedingly steep ramp that does not provide accessible use of elevated play components. Although there are a unique variety of free-standing ground play elements, including 2 wooden cars, 1 small cabin, a See-Saw, Multi-Pondo, and a sandbox; and, the play structure also offers 3 types of ground play elements, these elements are not accessible because the ground surface materials are not accessible and there are no accessible entry points into play areas. (Photo 12)

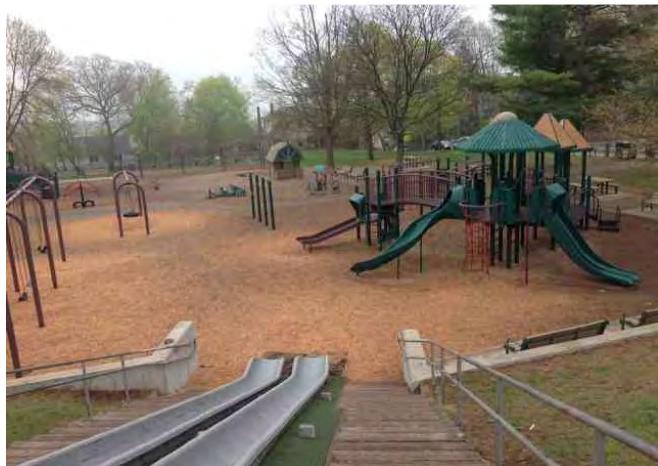
Photo 12

The composite play structure for older children does not include an accessible elevated route. The transfer steps do not lead to at least 51% of different types of elevated play features.

There are 8-13 inaccessible play features for older children, including the Long Slide, which is not connected to an accessible route from bottom to top. There are not a proportionate number of accessible ground or elevated play elements for children with disabilities, age 5 and older. (Photo 12)

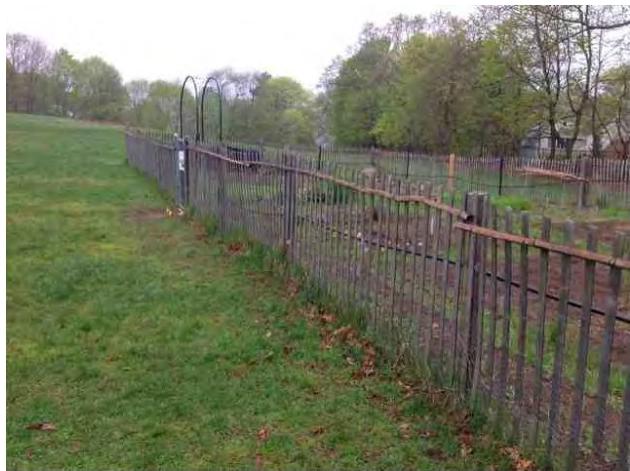
Photo 13

There is no accessible route connecting the Cooperative Community Garden to the park entrances, walkways or field paths. Within the enclosed garden area, there are no areas within accessible reach ranges, along an accessible route, or that can be approached via a firm, smooth, level and slip-free path. (Photo 13)

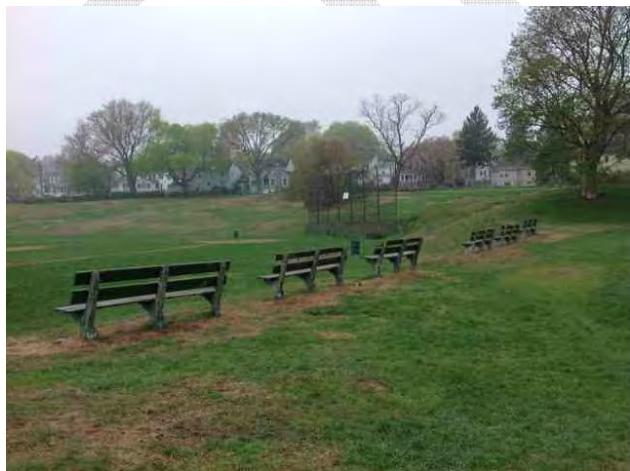
Photo 14

The soccer and ball fields are not located along an accessible route. Run slopes near benches indicate that an accessible route with handrails is feasible. (Photo 14)

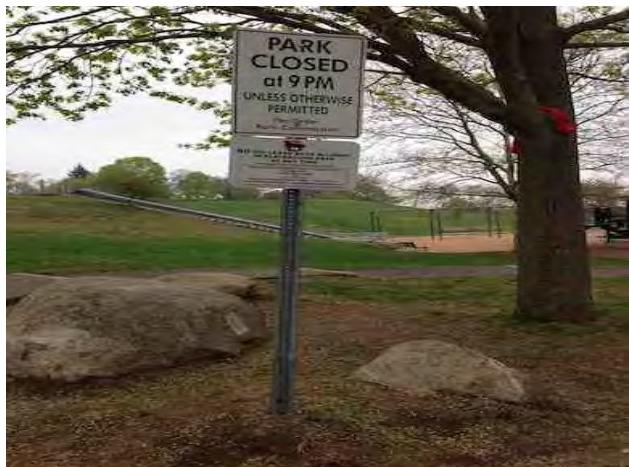
Photo 19

Signage denoting Dog Walk Hours and rules are posted too high proportionate to the approach and viewing distance provided along the trails. (Photo 19)

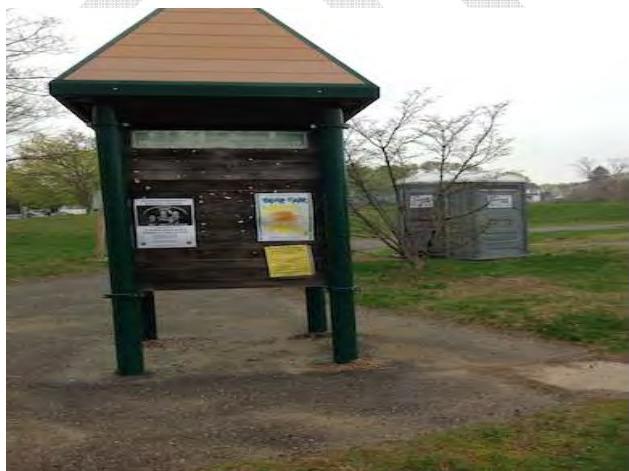
Photo 20

The information kiosk/bulletin board at the crosswalk entry point includes health information about Lyme Disease that is mounted above 60 inches from the ground and cannot be read because the font is too small. (Photo 20)

Signage, Best Practice recommendations:
Kiosk: Ensure that health information is posted with bottom line of text not lower than 40 inches and top line of text not higher than 60 inches.

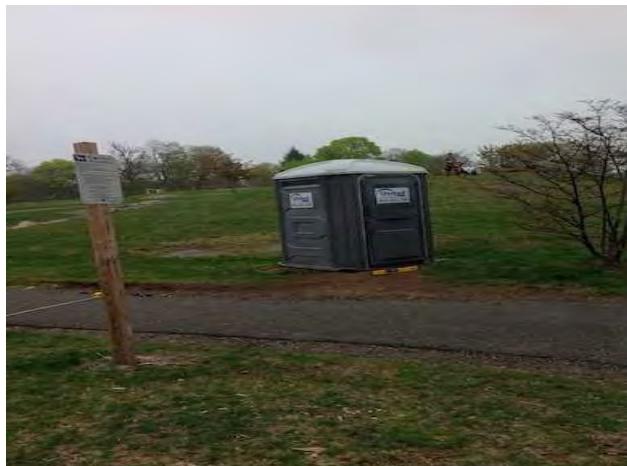
Photo 21

Rental of portable toilet began in 2012. This is an accessible portable bathroom; however, it is not located along an accessible route. The route from the walkway to the door is dirt mixed with gravel and is steep, not slip-free, not firm and not level. (Photo 21)

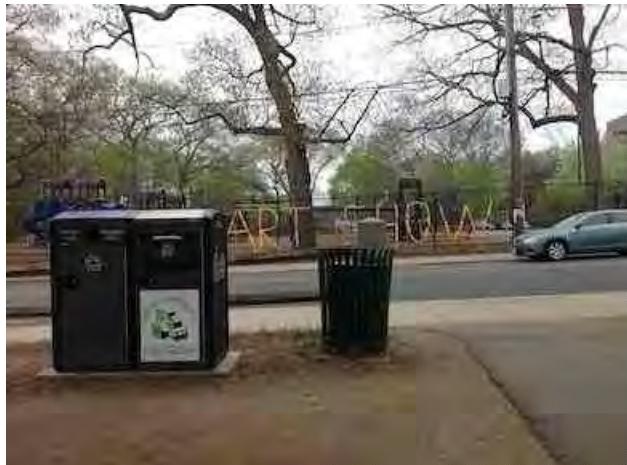
Photo 22

The recycling compactor is not located along an accessible route and is located on a platform, which does not provide accessible reach ranges or accessible clear space for forward and parallel approach. (Photo 22)

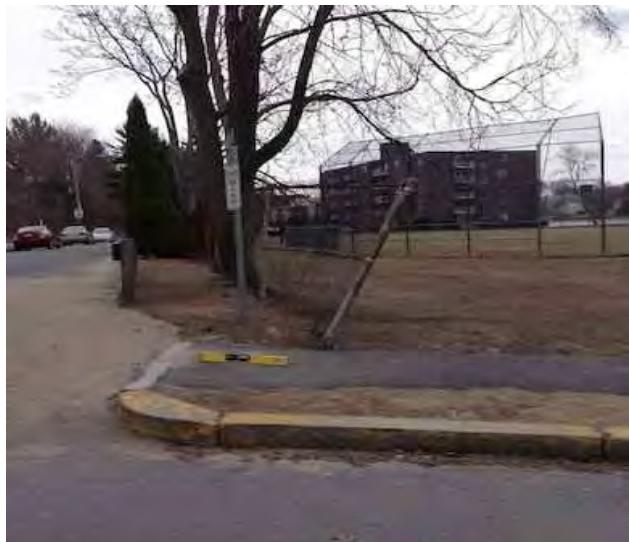
Photo 2

There is no accessible approach to the facility entrance because of missing curb ramps and uneven sidewalks. A curb ramp is missing at the southwest corner intersection, Hamilton St. and Linwood St. (Photo 2)

Construct an accessible pedestrian route from Mass Ave to Linwood Circle. Add curb ramps where missing.

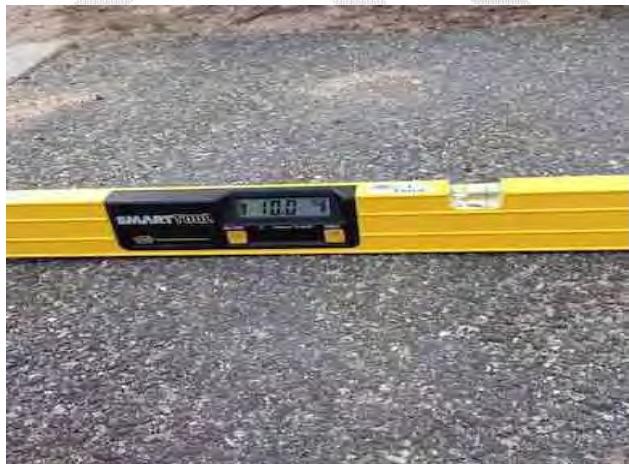
Photo 3

The sidewalk adjoining facility and around rotary has excessive slopes, and needs maintenance. (Photo 3)

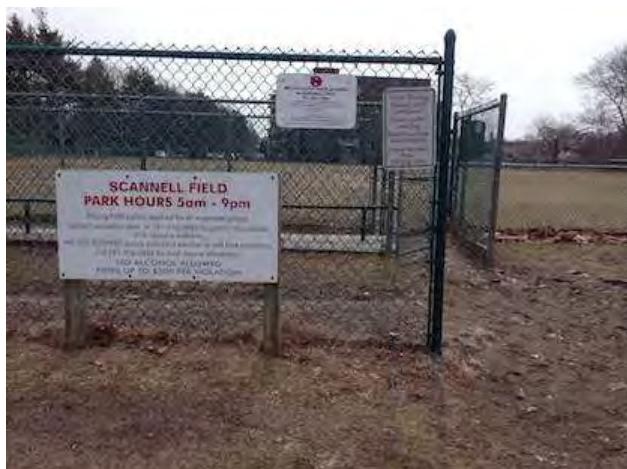
Photo 5

There are gated points of entry around the fenced-in field and to the home and away-team dugouts. No entry points are connected to an accessible route. There is no firm, level and slip-free walkway to the fence limits, field, dugout areas or bleachers. (Photo 5)

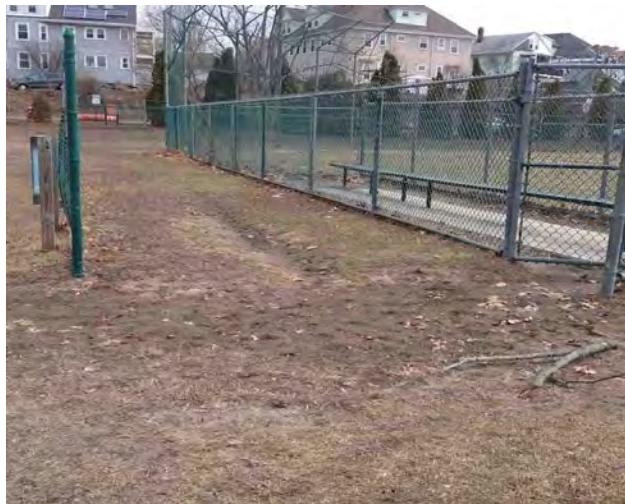
Photo 7

Gates are missing a smooth surface or kickplate. There is no level, firm and slip-free ground surface. There is inadequate maneuvering clearance from dugout to field because the gate does not fully open to at least 36 inches.

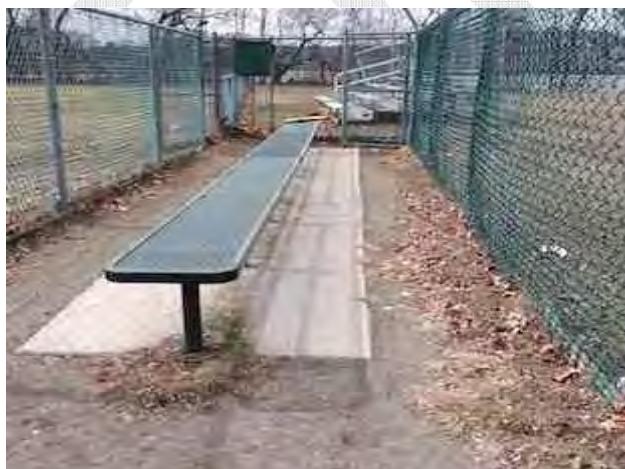
Photo 9

There are no accessible routes within the team seating areas. There is no accessible integrated wheelchair seating location within dugouts. (Photo 9)

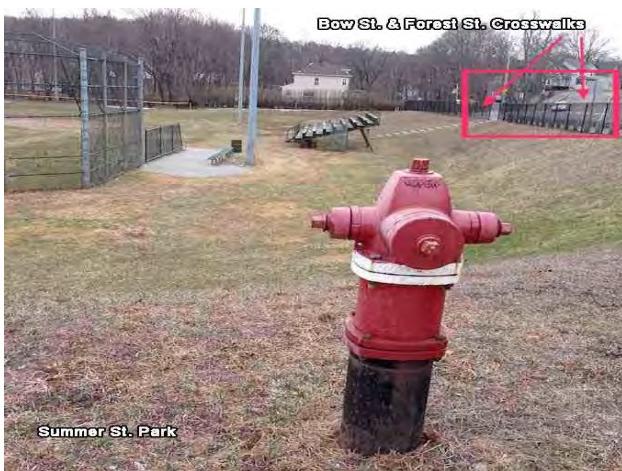
Photo 1

Summer St. Park has two points of entry at Forest St. and both entries have staircases and no accessible points of entry. The staircases lack handrails on either side and do not adjoin an accessible route from entry to boundary of sports playing fields, team seating area and bleacher areas. (See Photos 1 & 2)

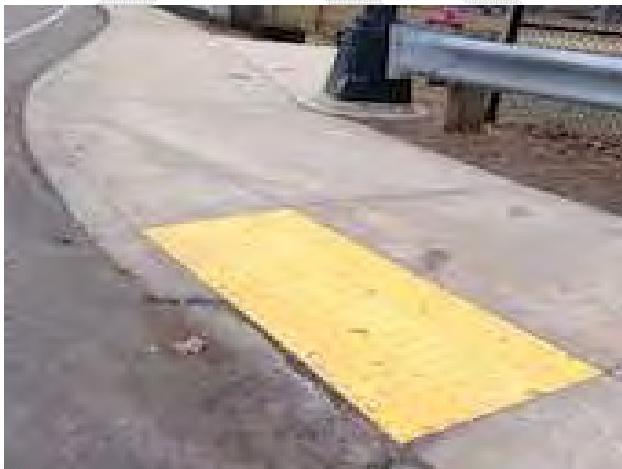
Photo 3

- Excessive cross slopes at sidewalk panels adjacent to three Accessible Pedestrian Signal controls (APS);
- Curb ramps are not oriented into crosswalks;
- Excessive cross slopes in sidewalk routes between new curb ramps;
- Sidewalk joints over 1/2 inch width; and
- Curb ramp transitions at gutter are in disrepair. (Photo 3)

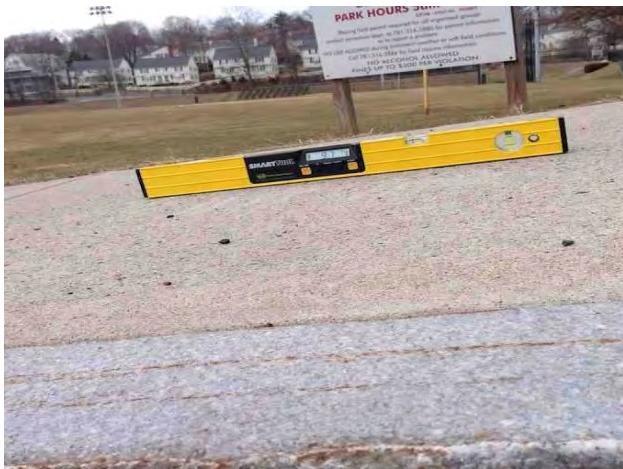
Photo 5

Due to natural terrain issues, this sidewalk needs to be ramped, with handrails. Cross slopes can be mitigated to compliance; run slopes will exceed 5%. (Photo 5)

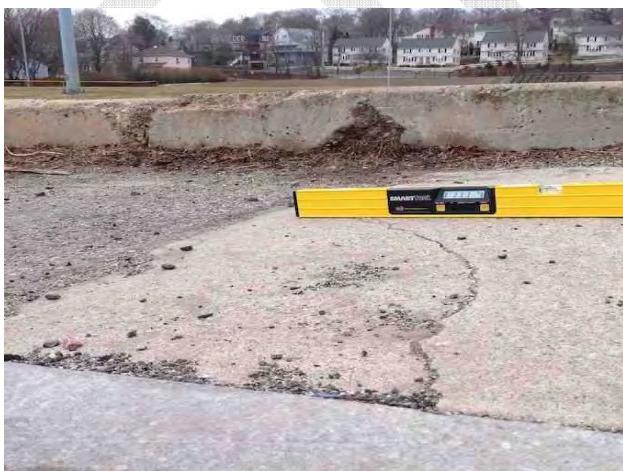
Photo 6

The line of work for this sidewalk ends prior to the Summer St. point of entry and the stone dust path does not provide an accessible site arrival point into the Park. (Photo 6)

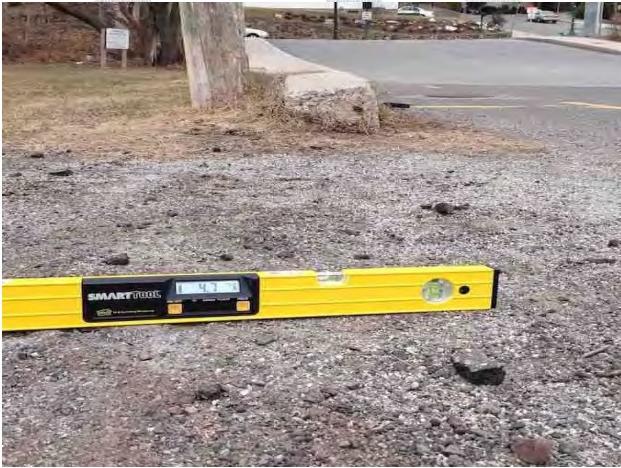
Photo 9

Along Ryder Street, marked point of entry is an eroding stone dust path. This path has excessive cross slopes and does not connect via an accessible route to any other facility program areas. (Photo 9)

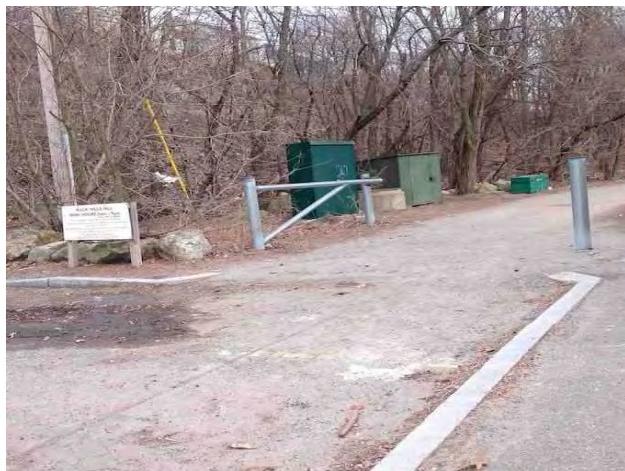
Photo 19

Sidewalk path to facility has excessive cross slopes and is not level. There is no smooth, level and accessible entrance area into the Buck Field/ Hill's Hill facilities at this point of entry.

This point of entry is used as a service entrance for maintenance and needs to provide a smooth, level, firm, slip free route without water and other weather event accumulation. There are currently no accessible route components provided at this point of entry. (Photos 19, 20)

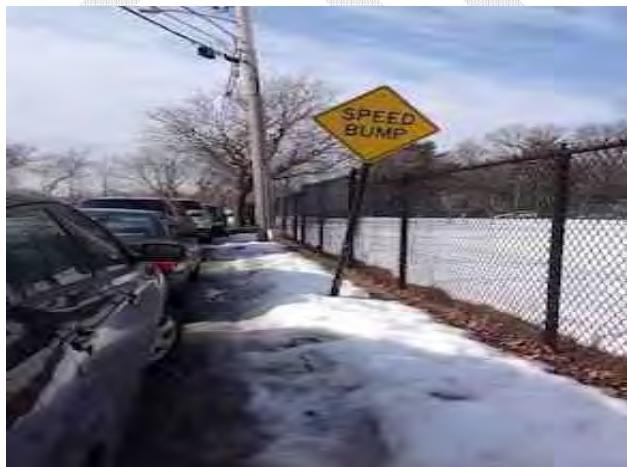
Photo 3

South and southeast facility entry points are not located along any accessible routes, and sidewalks are incomplete or missing. (Photo 3)

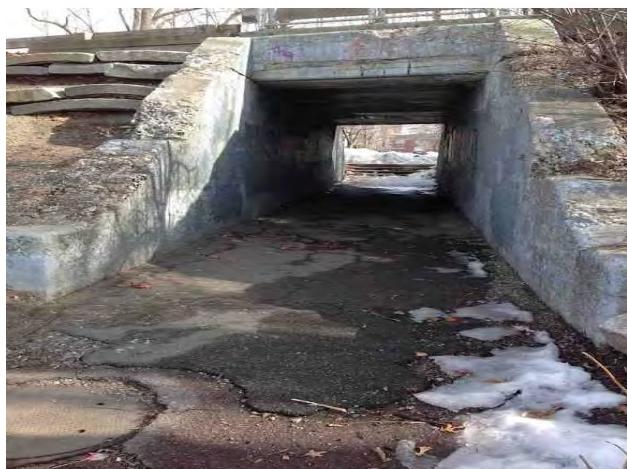
Photo 5

A long-range recommendation is for the 4-stair entry at the Whittemore St. underpass to be replaced with a ramped accessible entrance onto facility SE field. (See Photo 5, above)

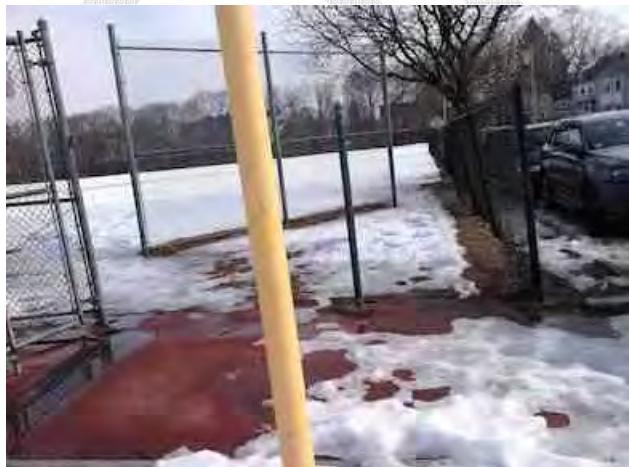
Photo 8

Two public gated entry points from public streets to facility are not along an accessible route and do not provide smooth, firm, level and slip-free ground surfaces. West Tennis Court gate does not open to at least 32 inches. Pond Lane gate approach is obstructed by on-street parking, lack of sidewalk route, and a paved entryway that is in disrepair with excessive cross slopes and tripping hazards. Gates require smooth surface or kickplate on push side. (Photo 8)

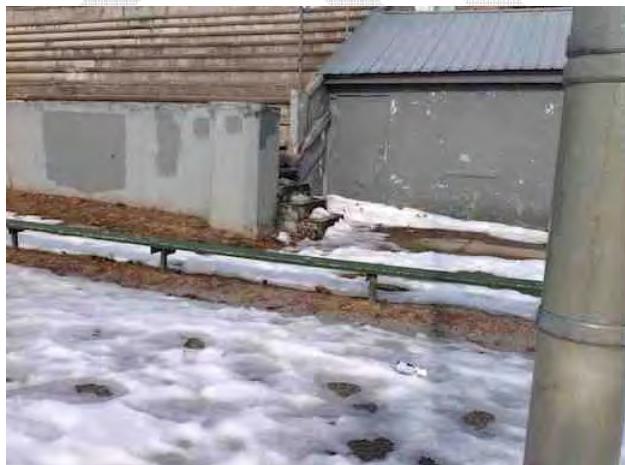
Photo 11

The historic concrete structures at Hornblower field (Play Fair Arch and Grandstand bleachers) are accessed by stairways along both ends and through the middle. Stair concrete is spalling and stairs require careful repairs to be made safe and retain historic character. When Grandstand is repaired, it may be possible to add continuous handrails going up to Lombard St. at one or two one staircases along grandstand. (Photo 11)

There needs to be an accessible route connected to the Team seating locations, and all Team meeting locations. Each team seating locations needs to provide a clear ground space for accessible integrated wheelchair seating. (Photo 11, above)

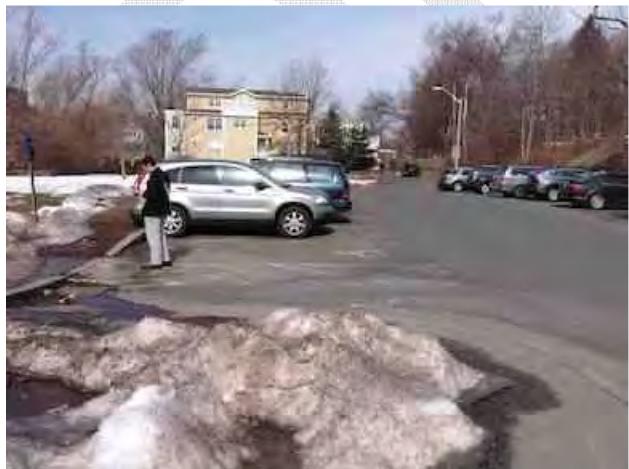
Photo 3

A curb ramp is provided at the North Beach Parking Lot in front of the 2 HP-designated spaces that share an access aisle. This inaccessible element has excessive cross slopes, excessive gaps and excessive level changes at gutter-to-ramp and ramp-to-sidewalk transitions. It lacks clear turning space and leads to a sidewalk with excessive slopes. (Photo 3)

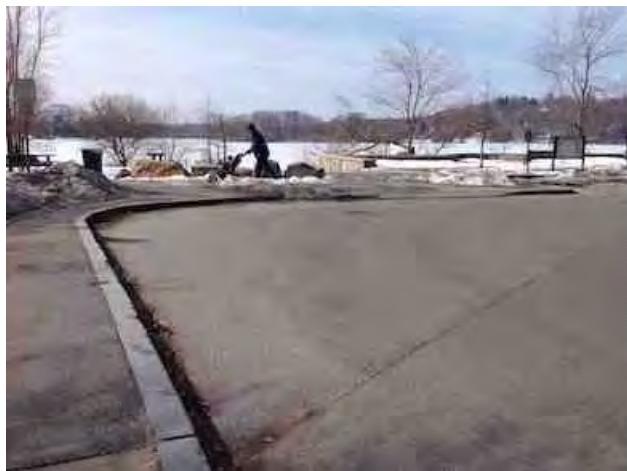
Photo 5

There is no accessible sidewalk connection to facility paths, spaces, elements and amenities to points south of the parking lot due to the non-level, non-smooth ground surface border of lengthwise cobblestones that mark the beginning of the Shoreline Path at North Beach.

Point of entry to facility from points east and north are hindered by lengthwise cobblestone border embedded at head of facility walkway (Photo 5)

North Beach At head of Shoreline path at bollards gate, design and install solution to uneven surface caused by embedded cobblestones at point of entry.

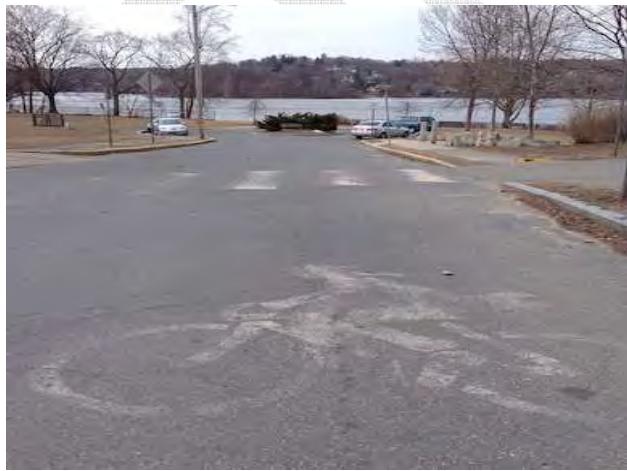
Photo 9

The limited parking lot sidewalk only leads towards the Boat Ramp walkway and does not provide clear space or level and slip-free approach to the signage or any amenities at the Overlook Park area of Spy Pond Park. (Photo 9)

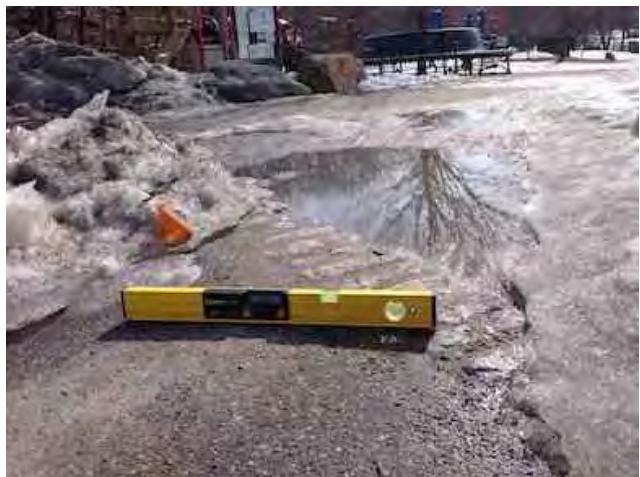
Photo 10

Point of entry through the parking facility and nearby municipal and associate programs at Spy Pond Fields & Tennis Courts and Boys and Girls Club is inaccessible because Pond Terrace lacks sidewalks and Pond Lane sidewalks are uneven, narrow, and have many gaps, level changes and discontinuities. (Photo 10)

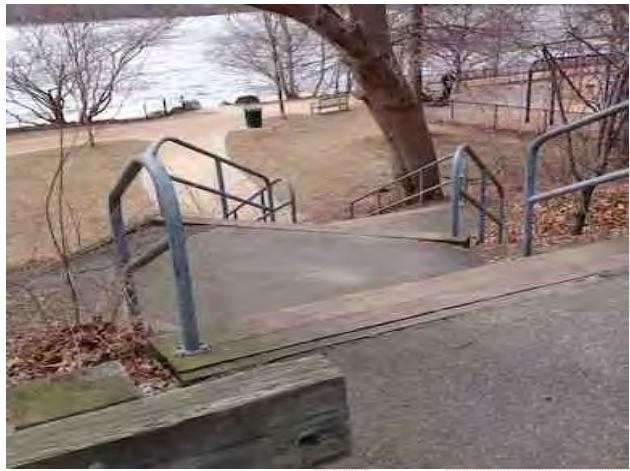
Photo 11

Point of entry and link to the Minuteman Commuter Bikepath from Spy Pond Shoreline trail is a path to a staircase built of repurposed railroad ties. There is no accessible route or ramped walkway matching this staircase linkage.¹ (Photo 11)

There needs to be directional signage at the path leading to the inaccessible stairway that currently serves as one of the pedestrian links between the Spy Pond Park and the Shared-Use Minuteman Bikeway Trail. This signage should provide clear directions so that pedestrians are aware of an accessible pedestrian link between the Spy Pond Park and the Shared-Use Minuteman Bikeway near Linwood Circle. (see Photo 11)

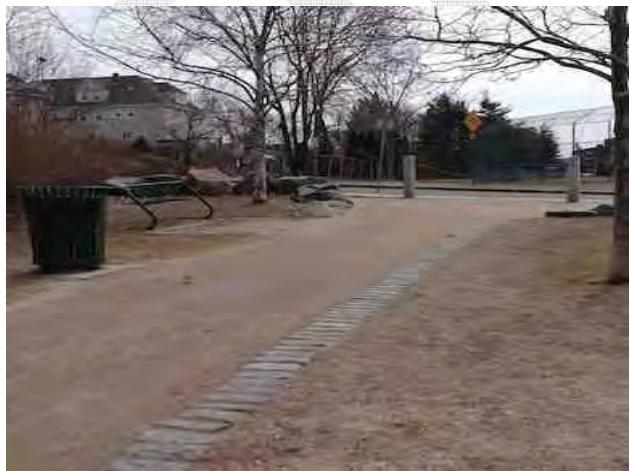
Photo 12

Point of entry to the South Beach Shoreline path is not accessible because the lengthwise cobblestone border at the head of the trail, similar to the head of the path from the North Beach, does not provide a level, smooth and slip-free transition between the Linwood Circle sidewalks and the graded shoreline path. This continuous edging also acts as a barrier to access the tables, benches, some trash receptacles and other viewing amenities along the length of the shoreline path. (Photo 12)

South Beach At head of Shoreline path at bollards gate, design and install solution to uneven surface caused by embedded cobblestones at point of entry.

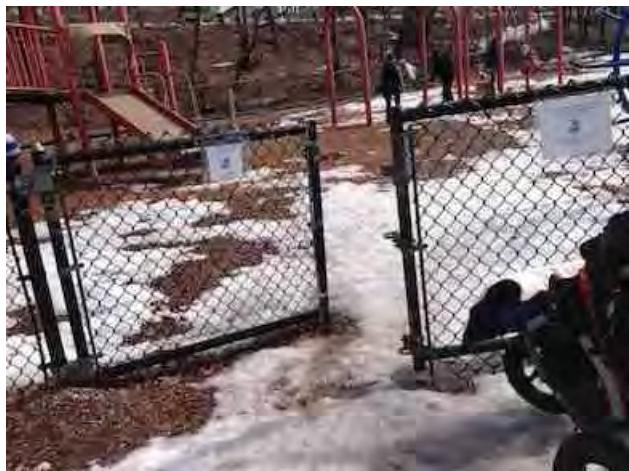
Photo 13

The Playground gate entrance, at North Beach, has an uneven, unstable ground surface which accumulates water. There is inadequate clearance width at the opening because the ground surface includes uneven areas that hinder a 90-degree swing of the gate. Gate requires a smooth surface or kickplate on push side (2010 requirement). (Photo 13)

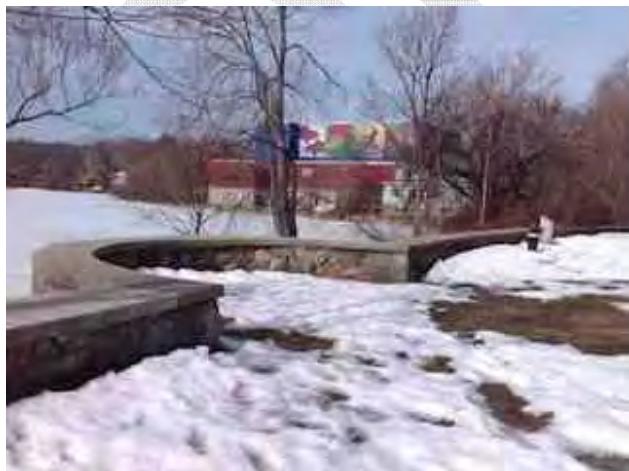
Photo 15

The Overlook area, dedicated in 1994, contains no accessible route to the public amenities in this area, including benches, signage, overlook bays, and memorial markers. (Photo 15)

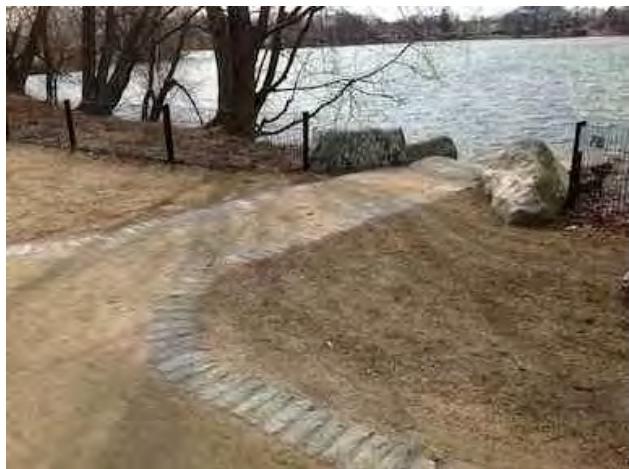
Photo 16

Viewing areas include well-graded paths need to be wide enough to provide turning-around space (minimum 5 feet unobstructed width). Thus, these viewing amenities are not currently accessible, safe and usable. (Photo 16)

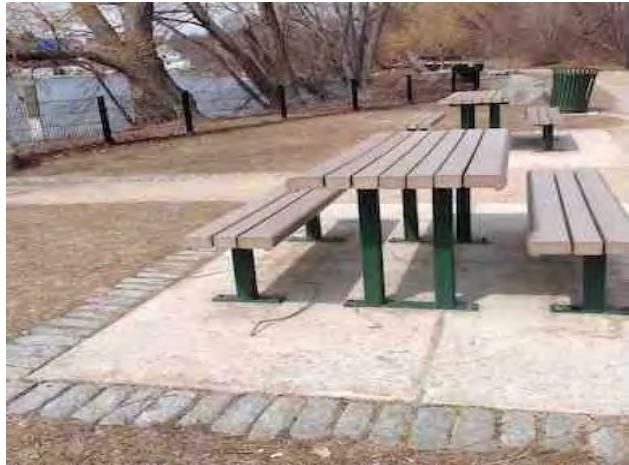
Photo 17

Picnic areas do not include accessible route because the cobblestone edging is not smooth, level and slip-free. In addition, there needs to be a minimum four feet path to allow individuals using wheeled mobility devices to enter and circulate around the picnic table and bench areas. (Photo 17)

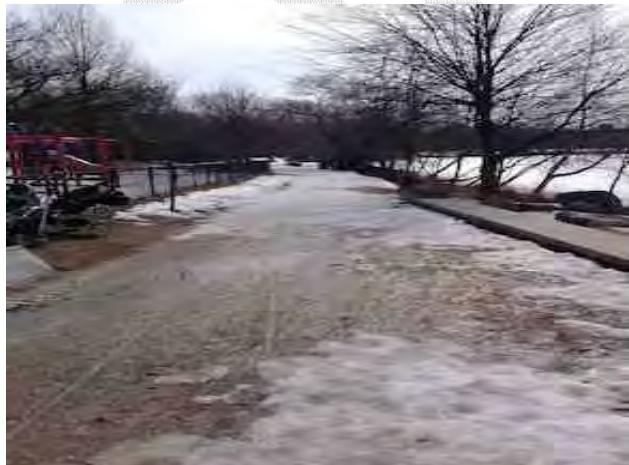
Photo 18

The shoreline path is well graded, clearly designated and includes ample passing space. Water accumulation, snow removal and ground surface displacement issues require regular and seasonal maintenance. (Photo 18)

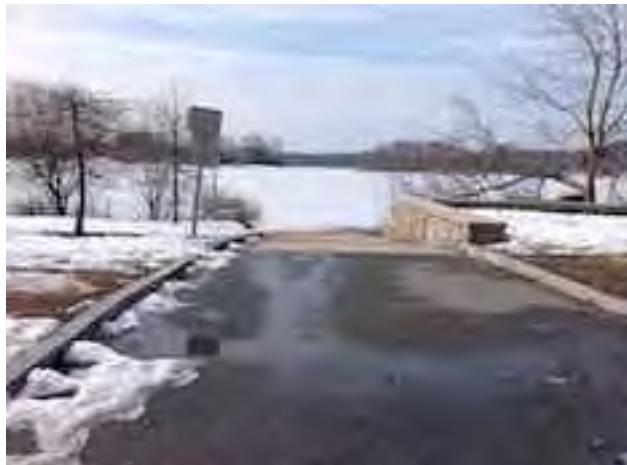
Photo 18

There is an accessible walkway with smooth surface and minimal slopes leading to the Boat Ramp. However, important safety signage regarding use of this facility is located adjacent to the corrugated surface instead of adjoining an accessible clear ground space.)(Photo 18)

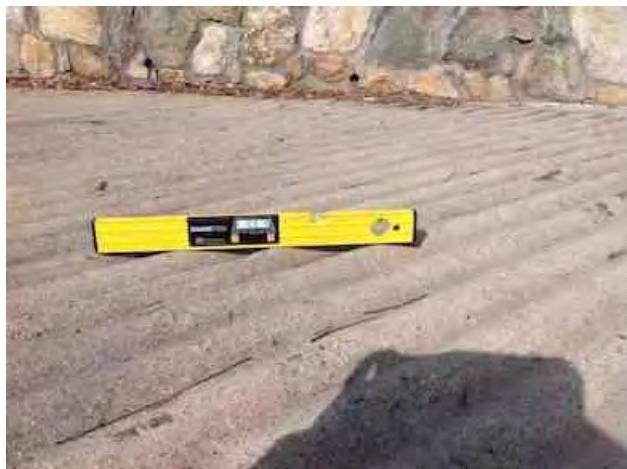
Photo 19

The construction of the Boat Ramp was completed without provision of an accessible route or inclusive adaptive sports programming. There is no provision of at least one 60-inch level boarding pier/launch dock for persons using mobility accessories to embark and disembark onto rowboats. There is no provision of a smooth walking surface. (Photo 19)

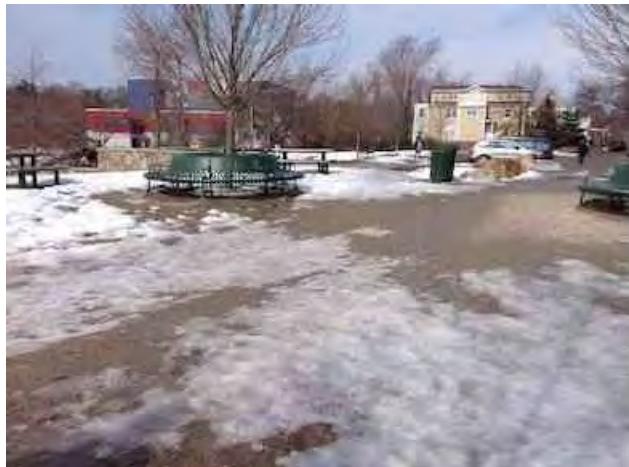
Photo 24

Seating areas, picnic tables, circle benches around a tree, trash receptacles and drinking fountains are provided through this linear facility, from north beach to south beach. These elements and amenities do not adjoin accessible routes and unobstructed firm, level ground spaces for integrated wheelchair seating are not yet included in seating and table arrangements. (Photo 24)

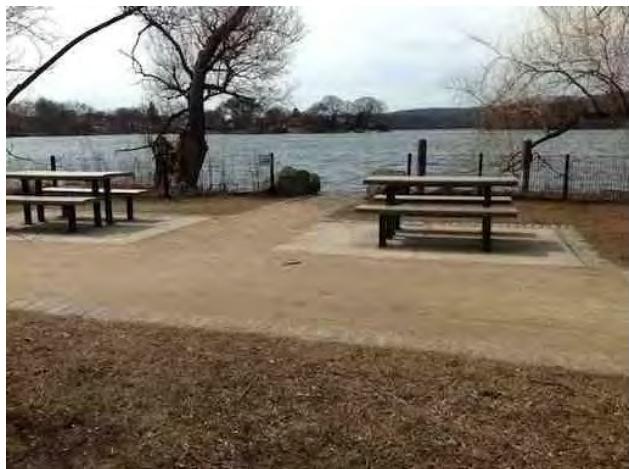
Photo 25

There are at least 7 picnic tables along the shoreline route from north to south. Tables are not connected to an accessible route. The ground surface under and around tables is uneven and slippery or, the level surface is not wide enough to accommodate an adjacent clear space of at least 30 inches by 48 inches along an accessible route. (Photo 25)

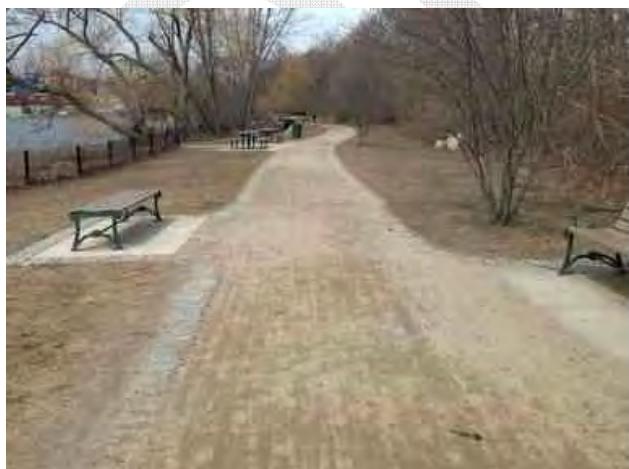
Photo 26

The benches are not connected by accessible route. The ground surface under and around benches is uneven and slippery. An adjacent clear space of at least 30 inches by 48 inches is not provided. At least one or 5% accessible benches at both North and South beach areas should be provided adjoining an accessible route. (Photo 26)

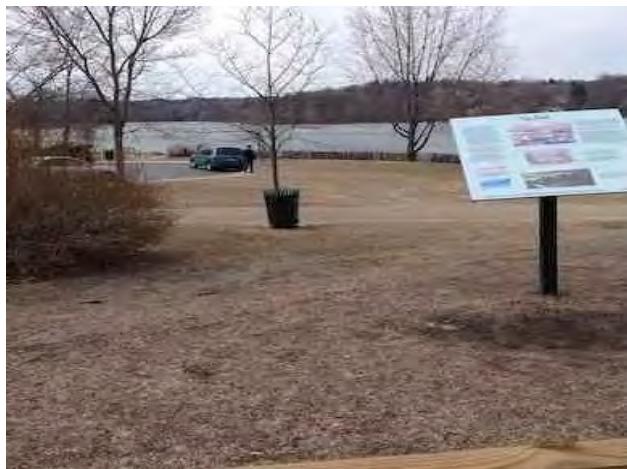
Photo 27

South Beach Sign installation is off the Bikeway path behind an erosion barrier. Sign is not accessible because ground surface to approach, view and read sign is not firm and slip-free. (Photo 27)

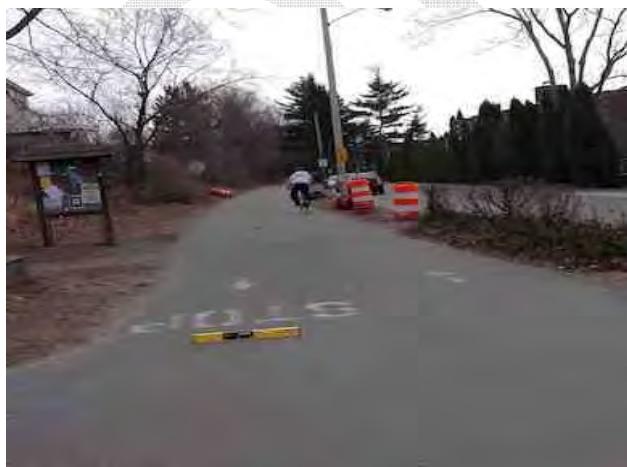
Photo 29

A community bulletin Board at South Beach Bikeway Connector does not provide an accessible forward approach to view and post community information signs. (Photo 29)

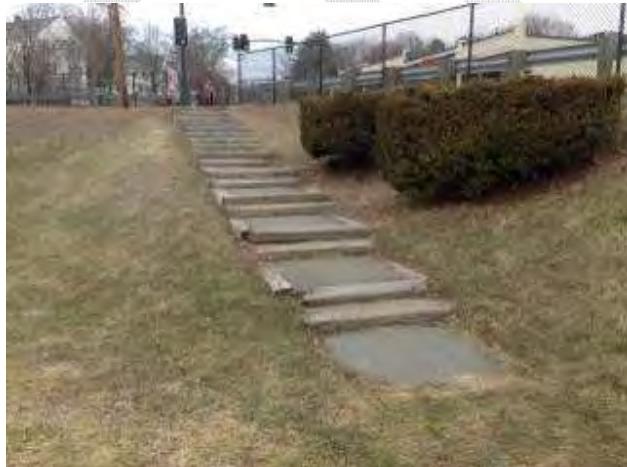
Photo 3

On Summer and Forest Street, stairways are in poor condition and are missing compliant railings on both sides. (Photos 3 and 4)

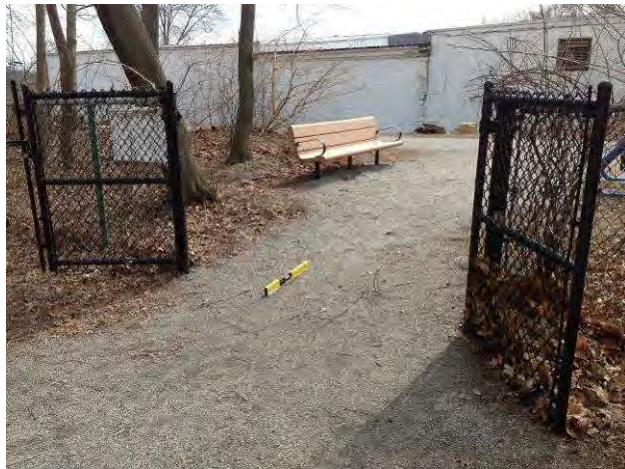
Photo 5

Along the Minuteman Commuter Bikeway, the asphalt walkway that leads to the multi-generational activity area has excessive running slopes (7%) and the asphalt walkway that leads to the parking adjacent to Ed Burns Arena is in poorly maintained. (Photo 5)

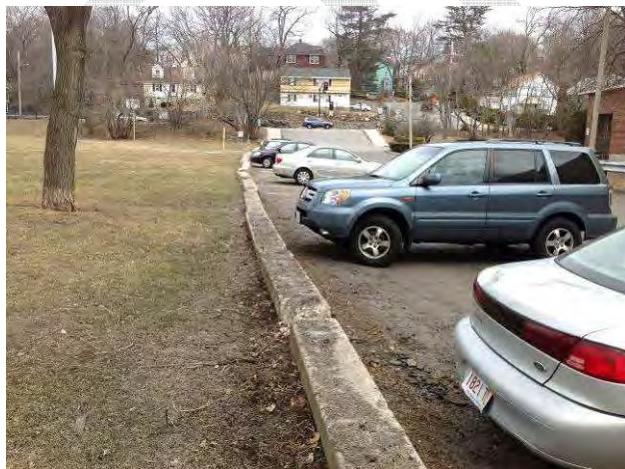
Photo 6

No accessible parking spaces serving this facility were identified in the parking lot adjacent to Ed Burns Arena. (Photo 6)

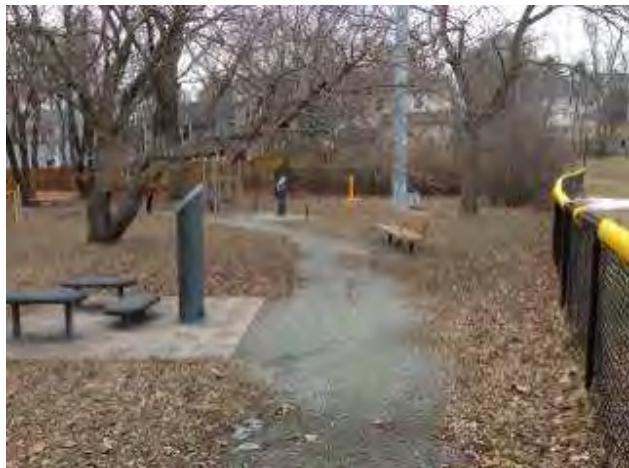
Photo 7

A stone walkway is provided between the parking lot adjacent to Ed Burns Arena and most features within the multi-generational activity area. However, in certain areas along the fitness course, the path is obstructed by tree canopies that extend onto the path. (Photo 7)

- 1 Interior Walkways:** Along the fitness course, trim trees so that branches over the path are no lower than 80" above the ground.
- 2 Field Playing Areas:** Install an accessible walkway between the point of entry and the baseball field and the grassy field used for field hockey.

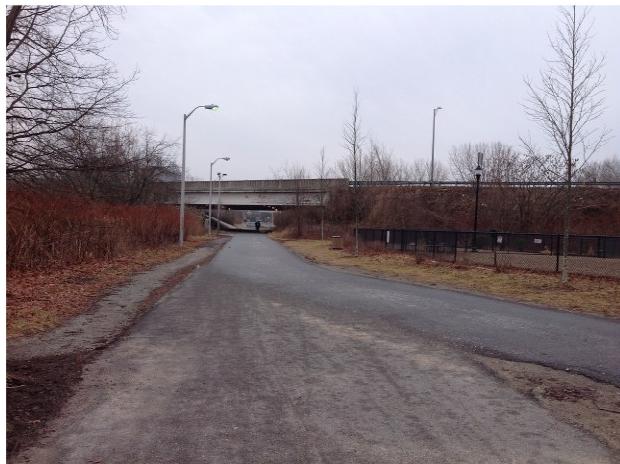
Photo 1

A stone path is provided between the parking lot and points of entry at the intersection of the parking lot and the Minuteman Commuter Bikeway. However, this path is poor condition and is uneven, unstable, a steep at certain sections. (Photo 1)

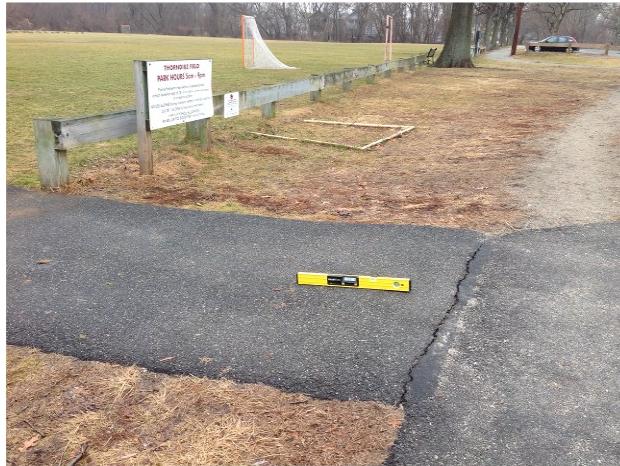
Photo 2

At the intersection of the parking lot and the Minuteman Commuter Bikeway, the asphalt walkway that leads to the grassy field has excessive running slopes (9.5% at the intersection with the bike path). (Photo 2)

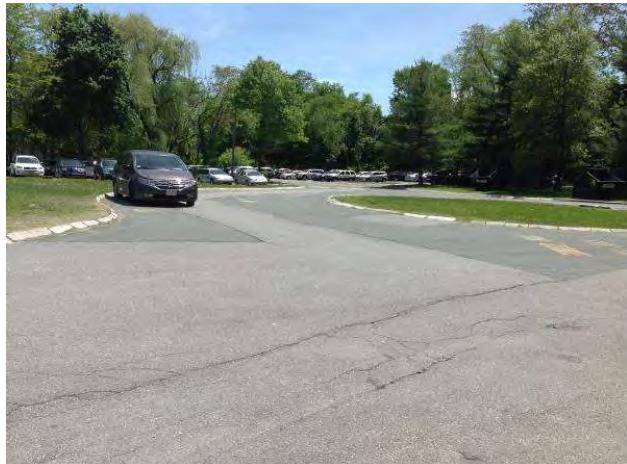
Photo 1

Public parking facility at Millbrook Drive has approximately 50 spaces, with two designated as accessible. The shared access aisle lacks the necessary width for van-accessible parking. (Photos 1, 2, 3)

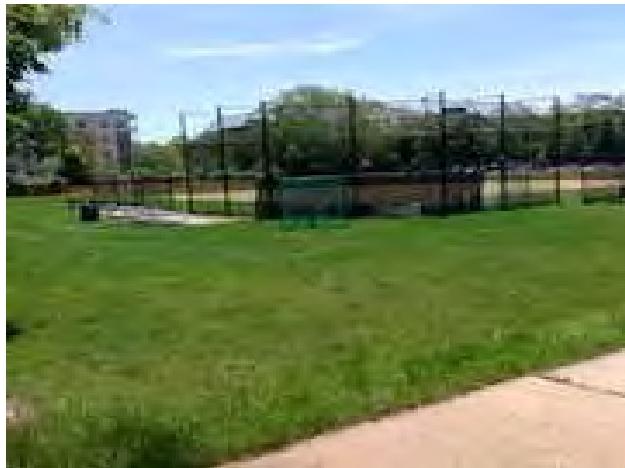
Photo 7

There is no accessible route to the boundary of the sports playing areas for either of these fields. (Photo 7)
